**ATLANTIC DIVISION
NAVAL FACILITIES ENGINEERING COMMAND
NORFOLK, VA**

AIRFIELD PAVEMENT CONDITION (PCI) SURVEY

NAS KEFLAVIK, ICELAND

JULY 2001

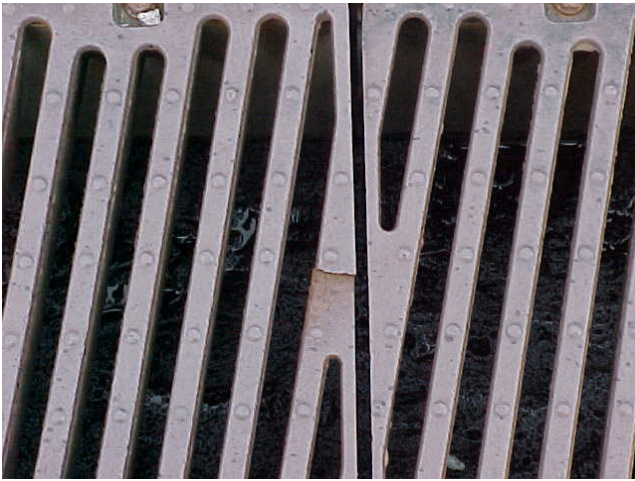
Figure 1. Stress crack on strip drain grate on east side of section CTA-1.

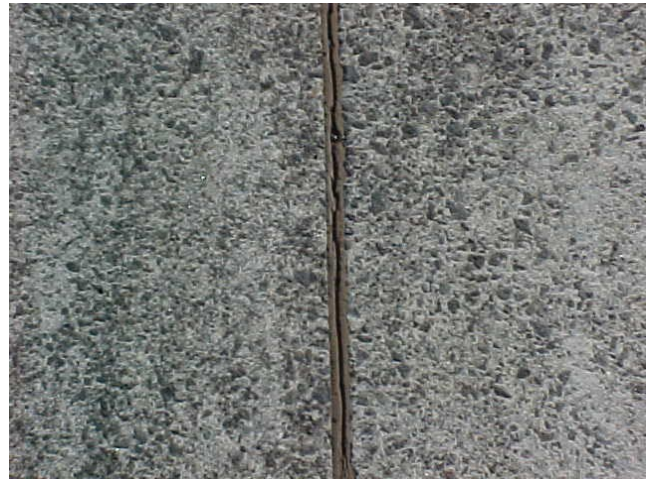
Figure 2. Cohesive failure in joint sealant on HCA-1.

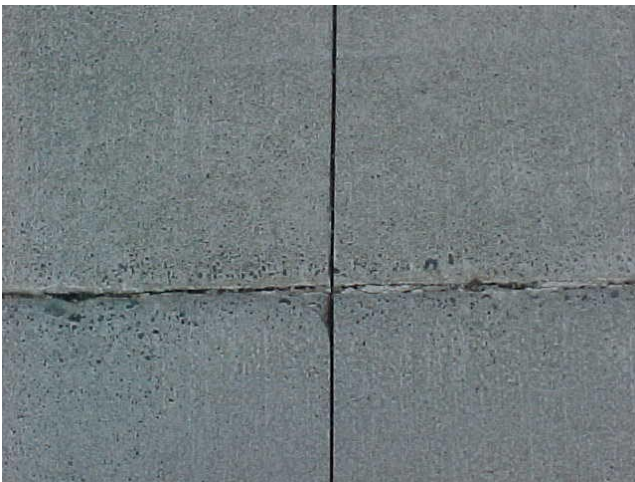
Figure 3. Unfinished joints on CTA-1.

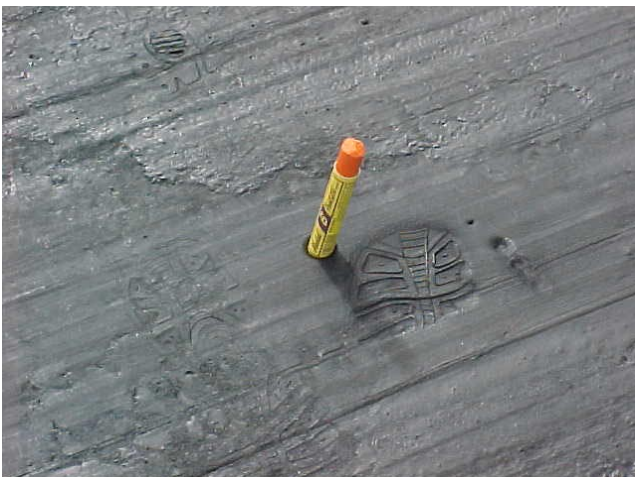
Section TE-5 contains numerous patches, however, all are in very good condition with a PCI of 84. As seen in Figure 5, there is a large patch using Flex-A-Fill. This patch is extremely slick and of low viscosity at 50°F. The use of this material should be limited to the small areas and cracks, as it may pose a braking hazard to ground support equipment and aircraft. It is recommended that this section be overlaid with 2" of asphalt in FY 2004, at which time the PCI will be at or below the required PCI threshold for taxiways.

Figure 5. Flex-a-Fill becoming extremely slick and flowable at 50°F.

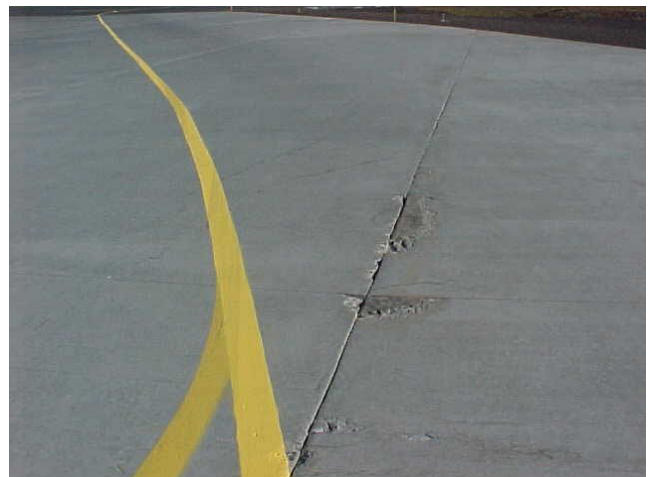
Figure 6. Joint spalling on CTA-1.

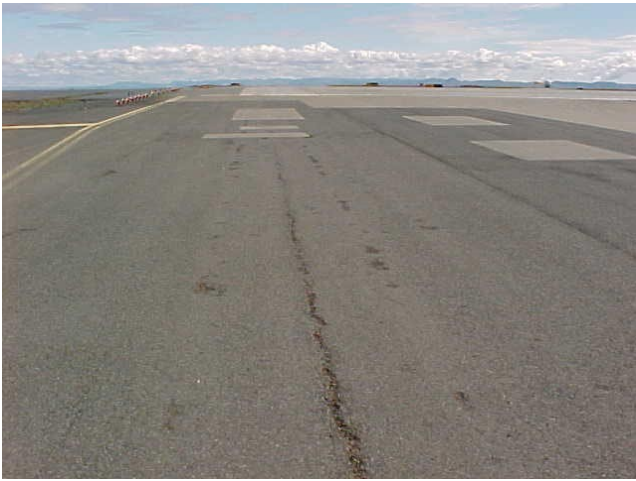
Figure 7. Section TE-5 looking east. Note the large crack width.

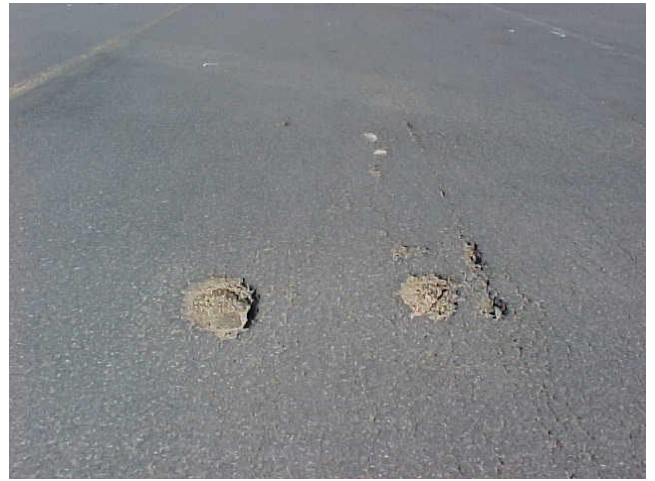
Figure 8. Potholes in the eastmost 50 feet of section KA-1.

KA-1	Patches being laid out on KA-1 are not large enough to remedy the defects present. Enlarge patch areas to 1-foot minimum beyond distress limits.

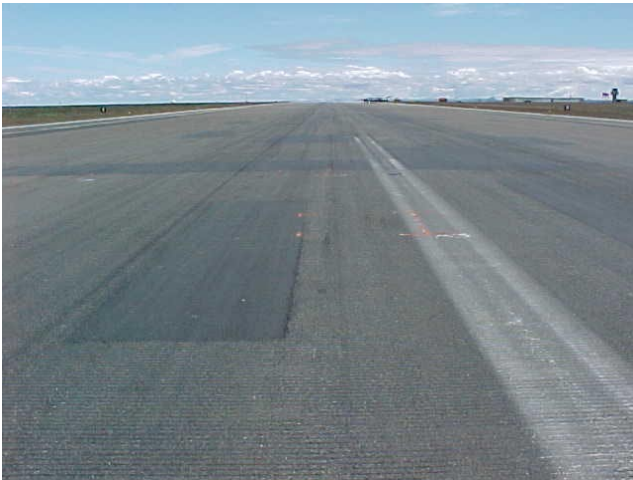
Figure 9. Recently completed patches on Runway 11-29.

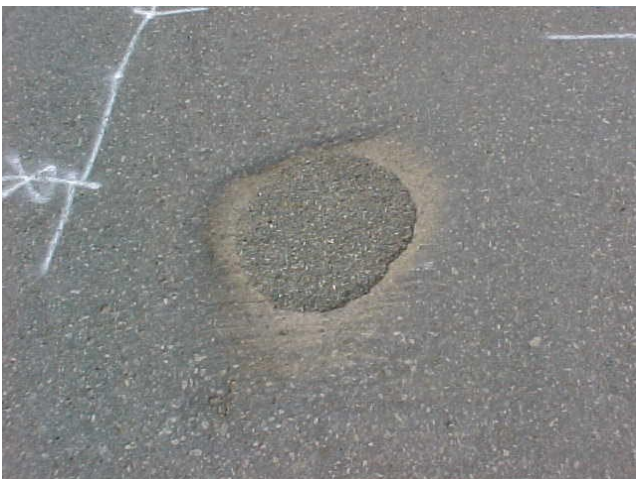
Figure 11. Improperly patched snowplow divot.

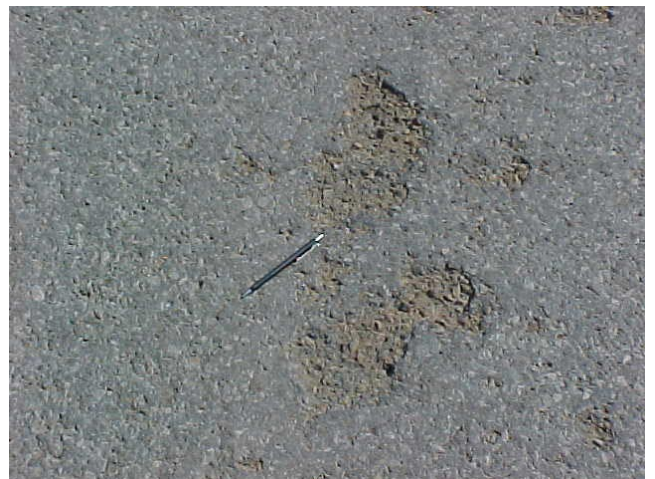
Figure 12. Poor asphalt mix in section TE-5.

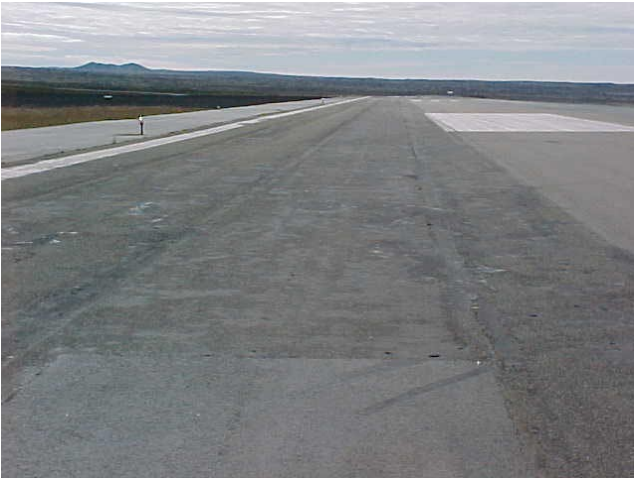
Figure 13. Deterioration of Ralumac on east sideline of Runway 02-20 .

It is recommended that sections R2-1A, 1B, 2A, and 2B be overlaid with 2" of asphalt across the full width of the runway in FY2004. Prior to overlay, the Ralumac micro surface should be completely removed to assure a good bonding surface is obtained.

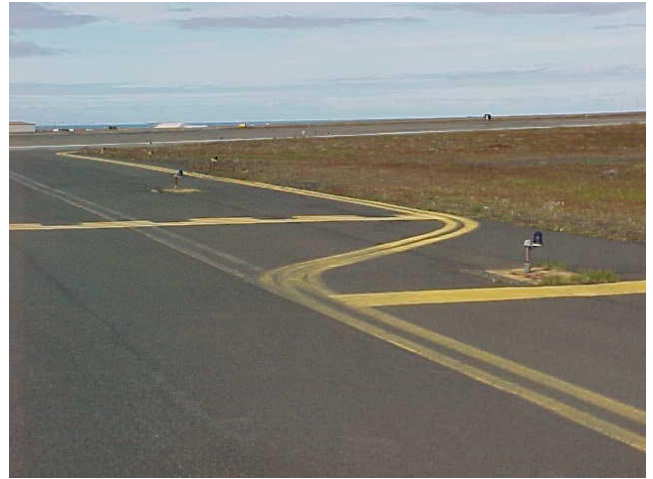
Figure 14. Exposed sideline light on North sideline of TS-1.

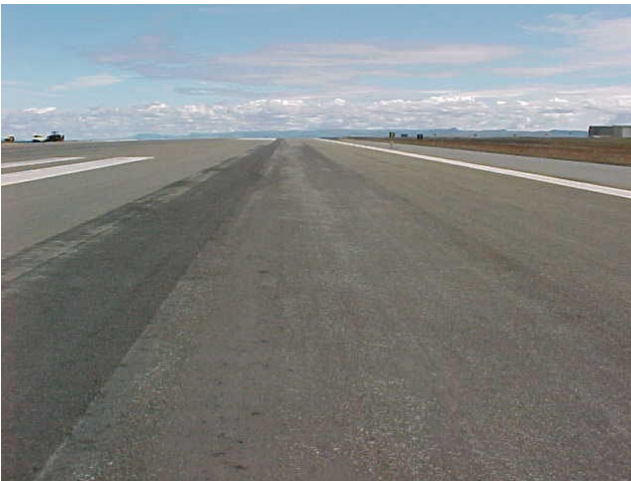
Figure 15. Raveling Ralumac on east sideline of Runway 02-20.

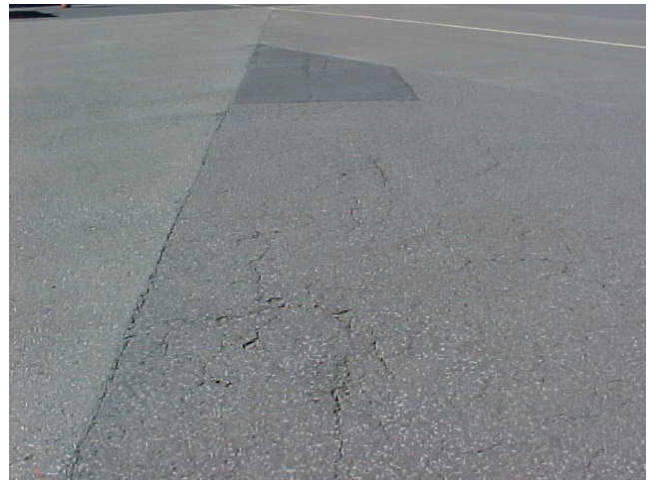
Figure 16. Raveling surface and crack at the paving lane joint on AHA-2.

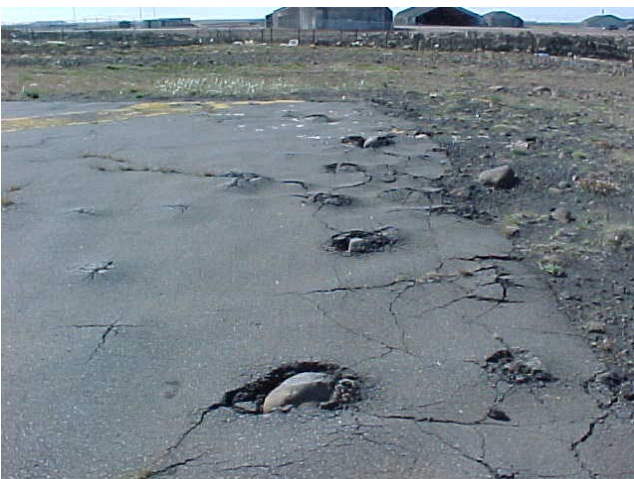
Figure 17. Rocks, the causative factor of the bubbles in R2-3A, being expelled through the pavement in the west overrun of 11-29.

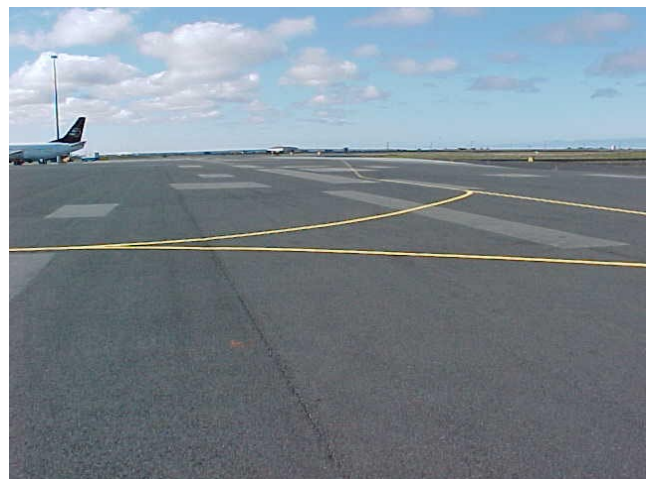
Figure 18. Patching in section CTA-1C.

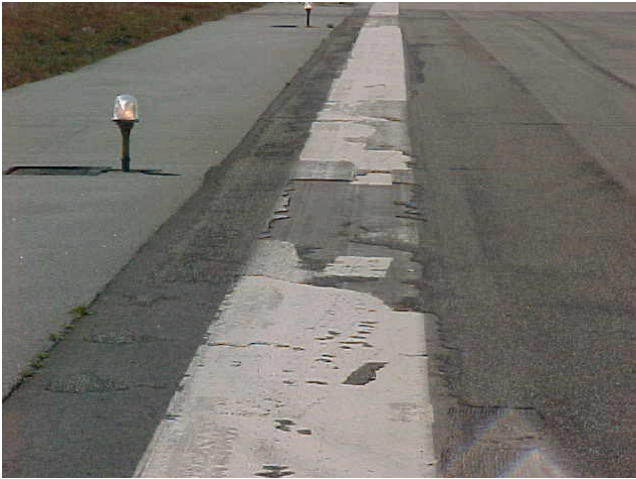
Figure 19. Deteriorating Ralumac on the west sideline of Runway 02-20.

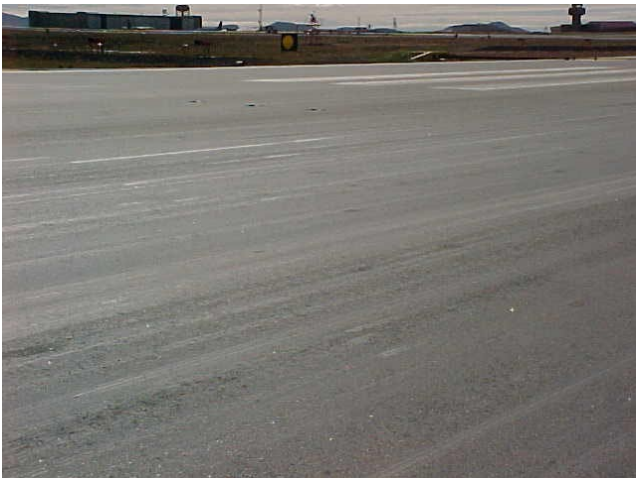
Figure 21. Bubbles, suspected to be rocks being heaved by frost, located in section R2-3A.

Branch/Section	Action Required
R2-3A, 3B	Mounds occurring on Runway 02-20 within the new overlay are believed to be heaving of stones/cobbles. Excavate (not core) at a few locations to verify. This condition is similar to what can be seen on the western most portion of feature HA11-1. This may be occurring in areas of relatively thin pavement. The pavement structure in section R2-3A and 3B consists of two asphalt layers. This pavement structure could be trapping water that would contribute to the formation of the mounds. Note that mounds will deflect under POV wheels.
TS-1 at Runway 02	Re-stripe Taxiway Sierra's north sideline on east side of Runway 02-20 where taxiway edge light falls inside the marked sideline (exposing light to traffic).
R2-2A1, 2B1, 3A, and 3B	Runway 02 sections 2A1, 2B1, 3A, and 3B have a smooth surface texture. These areas should have Mu meter runs and should be monitored for friction loss. Maintenance should be provided based upon evaluation of friction measurements using guidance set forth in FAA Advisory Circular 150/5320-12C.

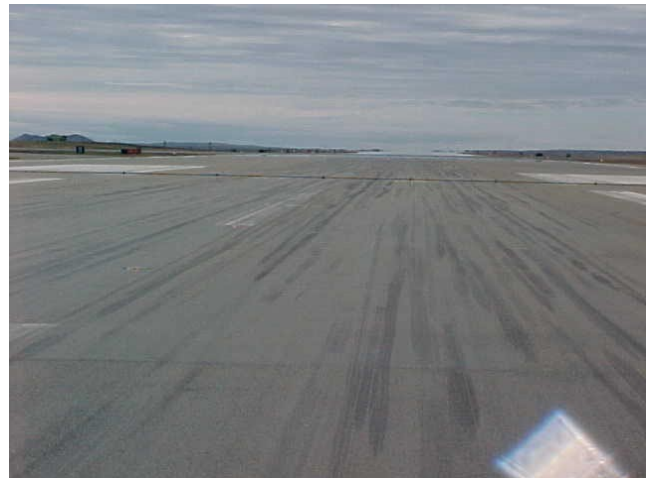
Figure 22. Minor rubber build-up at the arresting gear on Runway 02-20.

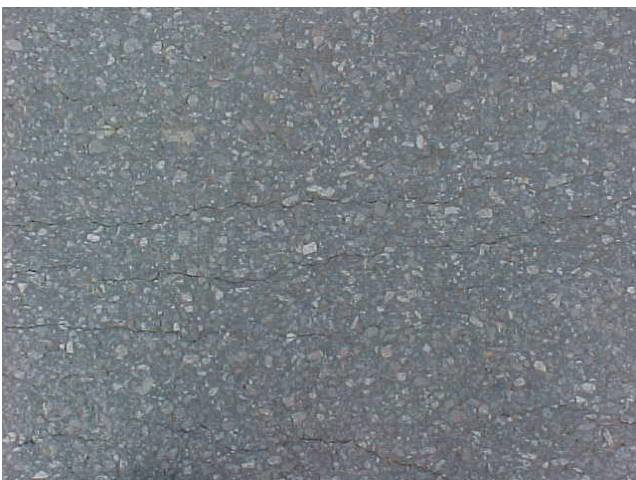
Figure 23. Alligator cracking on Taxiway Kilo.

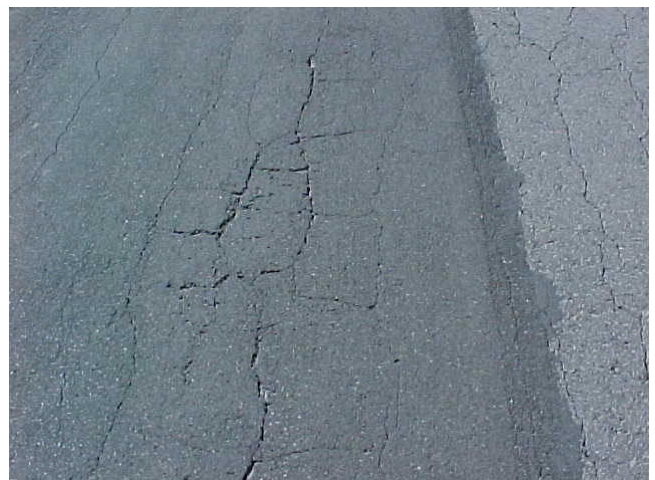
Figure 24. Alligator cracking through the patches in TK-3.
